F1FRV Octobre 2010

REPLACEMENT OF DARLINGTON TIP147
BY MOSFET FOR HIGH CATHODE CURRENT

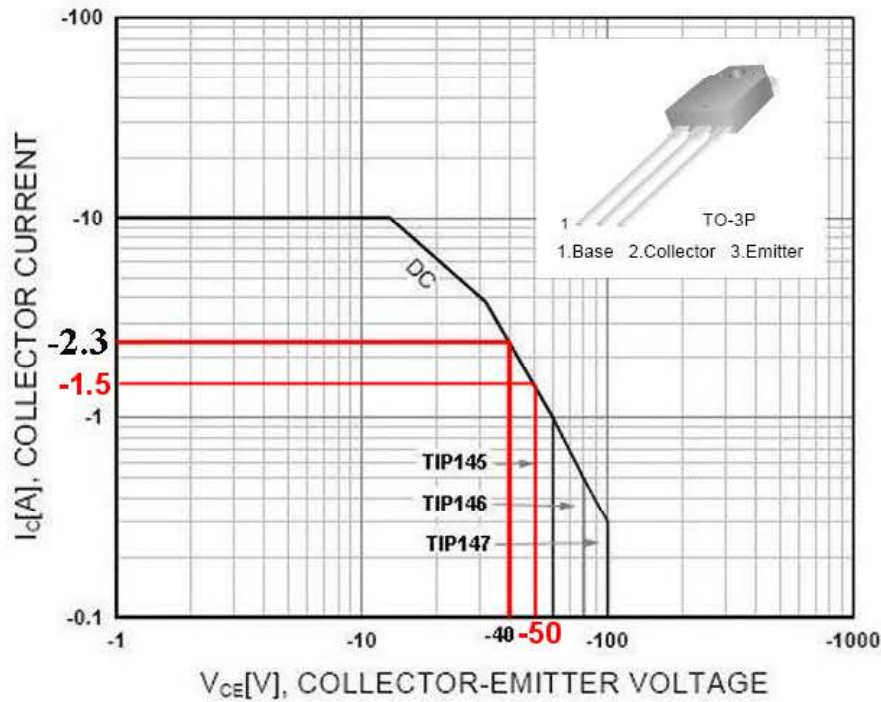
Figure 5. Safe Operating Area

TIP147 1.5 A @ 50 V
